**Flood Control Project Maintenance
Levee Inspections**
LMA District Cover Sheet
Spring 2019 Levee Inspection Results

Reclamation District No. 2068 Yolano

Spring 2019 Levee Inspection Results

Waterway			Bank	Unit Miles
Unit No. 01 Yolo Bypass			Right	5.48
	Spring (March - May)	Summer (June - August)	(September - November) Fall	Winter (December - February)
Unit Maintenance Rating (Fall Only)				
Date of Inspection	3/26/2019 - 3/26/2019			
DWR Inspector	David Julian			
Accompanied By	Bryan Busch RD 2068

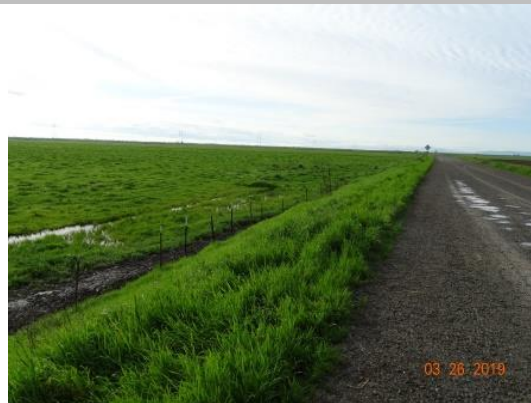
Photo 1 of 1 : SP_2019_RD2068_193_9_20190329_00020.jpg

LM Start	0.51	Rating **	M	Issue No.	9
LM End	2.50	Issue Type +	Ma	Location *	WS
Category	Earthen Levee			GPS Latitude/Longitude	
				Start	End
Item	Vegetation			38.401237 °	38.372257 °
				-121.693808 °	-121.693967 °
DWR ID	DWR_RD2068_01_s_2019_9				
Comment Code					
V1 : Control annual grass and weeds on the levee slopes and easements.					
Inspector Comment					
Maintain annual vegetation on the waterside slope.

View looking downstream at annual vegetation on the waterside slope (Spring 2019).

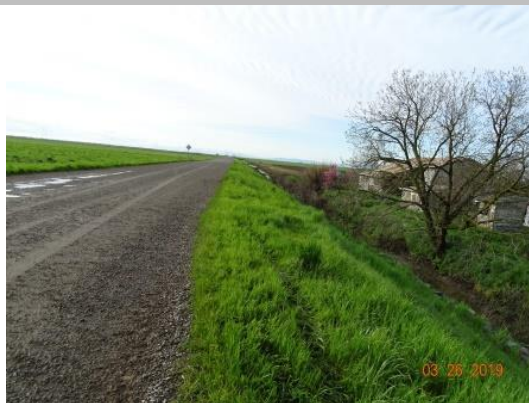
Photo 1 of 1 : SP_2019_RD2068_193_10_20190329_00021.jpg

LM Start	0.51	Rating **	M	Issue No.	10
LM End	2.50	Issue Type +	Ma	Location *	LS
Category	Earthen Levee			GPS Latitude/Longitude	
				Start	End
Item	Vegetation			38.401237 °	38.372257 °
				-121.693808 °	-121.693967 °
DWR ID	DWR_RD2068_01_s_2019_10				
Comment Code					
V1 : Control annual grass and weeds on the levee slopes and easements.					
Inspector Comment					
Maintain annual vegetation on the landside slope.

View looking downstream at annual vegetation on the landside slope (Spring 2019).

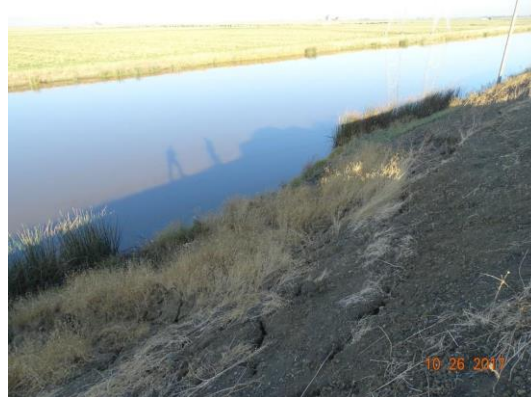
Photo 1 of 2 : SP_2019_RD2068_193_20_20190311_00001.jpg

LM Start	3.16	Rating **	A/W	Issue No.	20
LM End	3.19	Issue Type +	Ma	Location *	LS
Category	Earthen Levee			GPS Latitude/Longitude	
				Start	End
Item	Slope Stability			38.362765 °	38.362278 °
				-121.694040 °	-121.694050 °
DWR ID	DWR_RD2068_01_f_2018_20				
Comment Code					
S1 : Repair slope instability.					
Inspector Comment					
Repair the slope instability.

View of slope instability on the landside.

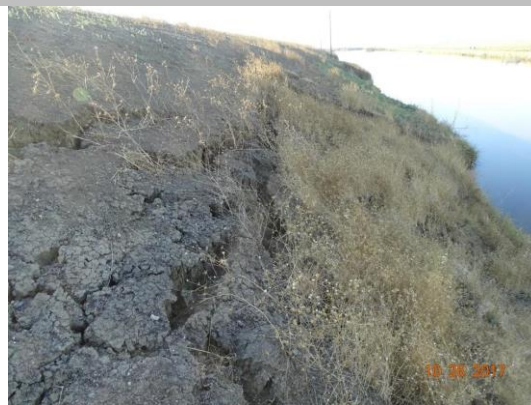
Photo 2 of 2 : SP_2019_RD2068_193_20_20190311_00002.jpg

View of the slope instability.

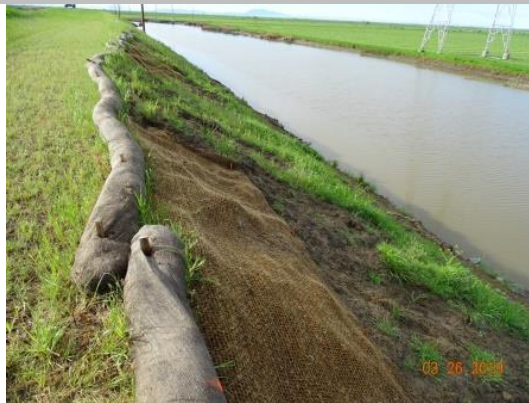
Photo 1 of 2 : SP_2019_RD2068_193_11_20190329_00023.jpg

LM Start	3.27	Rating **	M	Issue No.	11
LM End	3.48	Issue Type +	Ob	Location *	LS
Category	Earthen Levee			GPS Latitude/Longitude	
				Start	End
Item	Erosion / Bank Caving			38.361087 °	38.358140 °
				-121.694055 °	-121.694057 °
DWR ID	DWR_RD2068_01_s_2019_11				
Comment Code					
E1 : Note and monitor erosion site.					
Inspector Comment					
Repaired 2017 storm damage has a steep slope. Erosion is due to rainwater running down the steep slope.

View looking downstream at erosion due to rainfall on the landside slope (Spring 2019).

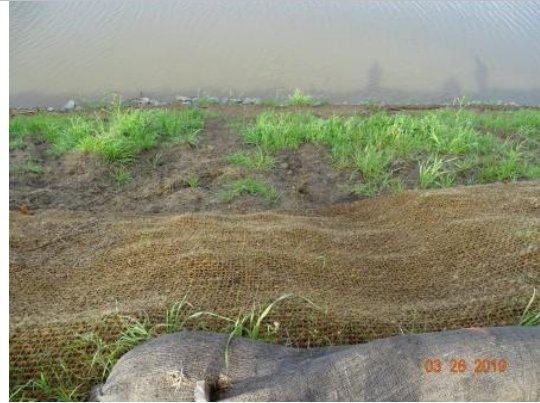
Photo 2 of 2 : SP_2019_RD2068_193_11_20190329_00024.jpg

LM Start	3.27	Rating **	M	Issue No.	11 (cont)	
LM End	3.48	Issue Type +	Ob	Location *	LS	
Category	Earthen Levee			GPS Latitude/Longitude		
				Start	End	
Item	Erosion / Bank Caving			38.361087 °	38.358140 °	
				-121.694055 °	-121.694057 °	
DWR ID	DWR_RD2068_01_s_2019_11					
Comment Code						
E1 : Note and monitor erosion site.						
Inspector Comment						
Repaired 2017 storm damage has a steep slope. Erosion is due to rainwater running down the steep slope.

View looking downslope at erosion due to rainfall on the landside slope (Spring 2019).

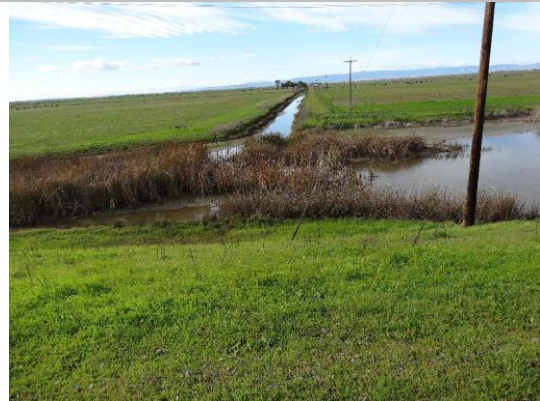
Photo 1 of 3 : UCIP_SP_2019_51451_76850.jpg

Comment Code					
Inspector Comment					
FS_ID:51451 DS_ID:19335 EP_NO: 7220 Repair Type: Non-Urgent Crossing Status: Indicator Found UCIP Comments: 12/06/2016 Line is abandoned according to a map obtained by the LMA. Gas line is labelled abandoned according to the map labelled "California Gas Transmission, Gas System Maintenance and Technical Support, Geographic Information Services", 5/10/2000 4:20 pm, City Solano, Division Sacramento, Zone 2, Wallmap #2-2649. Crossing has been downgraded from "Urgent" to "Non-Urgent" due to the supporting documentation provided by LMA to indicate gas line is abandoned. Need to contact owner to obtain as-builts for line abandonment. (O. Magana - DWR UCIP)08/08/2013 Pipe needs to have markers installed on both sides of levee. (W. Wylie - DWR UCIP) FIELD_STRUCT_DESC: 6.625-inch gas line of an unknown material through the levee, 3 feet below the crown. (Permit No. 7220, 1970 - Pacific Gas and Electric Company [PG&E]). [Additional Reference(s): DWR Levee Log, 1992]. FS Date: 12/6/2016

View of WS.

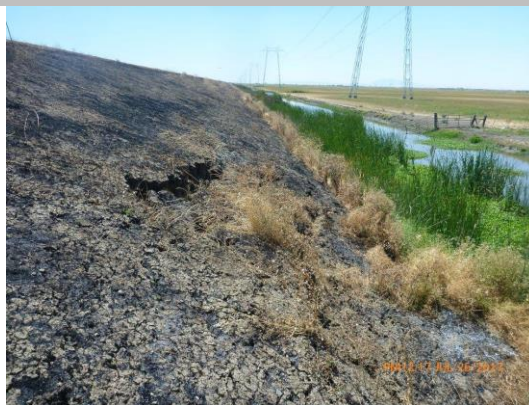
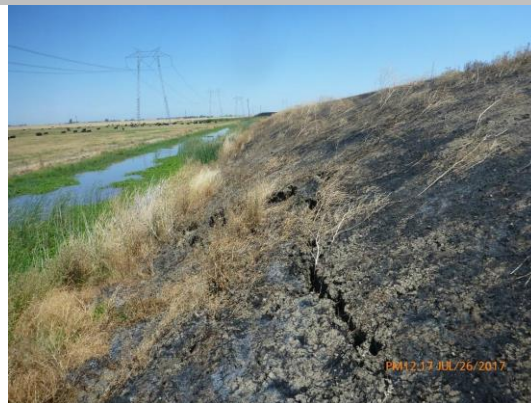
LM Start	3.73	Rating **	A/W	Issue No.	27
LM End	3.74	Issue Type +	Ma	Location *	LS
Category	Supplemental			GPS Latitude/Longitude	
				Start	End
Item	2017 Storm Damage			38.354500 °	38.354400 °
				-121.694000 °	-121.694000 °
DWR ID	DWR_RD2068_01_f_2017_27				
Comment Code					
Inspector Comment					
Levee Evaluation Comments					
Description:The damage consists of scour, cracking, and sloughing of the lower landside levee slope approximately 47 feet in length along the west (right) bank of Shag Slough (Yolo Bypass). See attached pages for photos.					
Site ID No:462					
Site Designation:LMA-289					
Repair Type: Stability					
Rating:Serious					
Field Date:7/26/2017					
Notes: 2' feet vertical cut on waterside levee toe from wavewash; site combined with LMA- 288 in field.

LM Start	3.73	Rating **	A/W	Issue No.	27 (cont)	
LM End	3.74	Issue Type +	Ma	Location *	LS	
Category	Supplemental			GPS Latitude/Longitude		
				Start	End	
Item	2017 Storm Damage			38.354500 °	38.354400 °	
				-121.694000 °	-121.694000 °	
DWR ID	DWR_RD2068_01_f_2017_27					
Comment Code						
Inspector Comment						
Levee Evaluation Comments						
Description:The damage consists of scour, cracking, and sloughing of the lower landside levee slope approximately 47 feet in length along the west (right) bank of Shag Slough (Yolo Bypass). See attached pages for photos.						
Site ID No:462						
Site Designation:LMA-289						
Repair Type: Stability						
Rating:Serious						
Field Date:7/26/2017						
Notes: 2' feet vertical cut on waterside levee toe from wavewash; site combined with LMA- 288 in field.

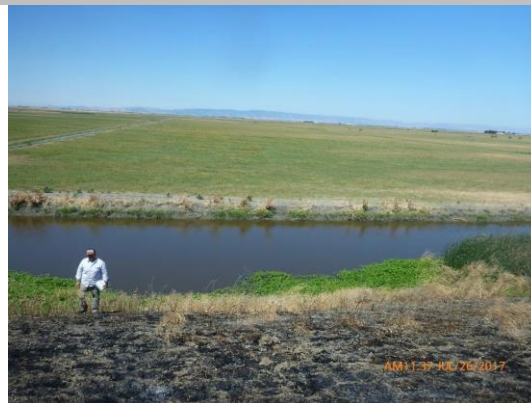
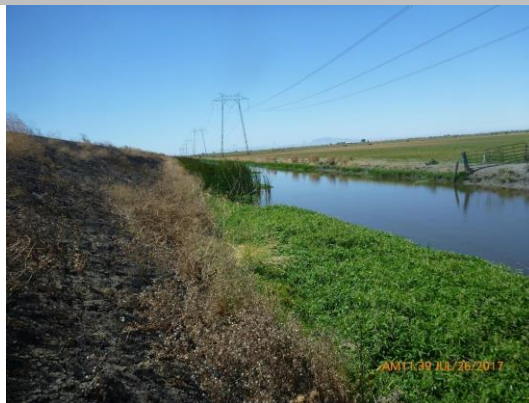
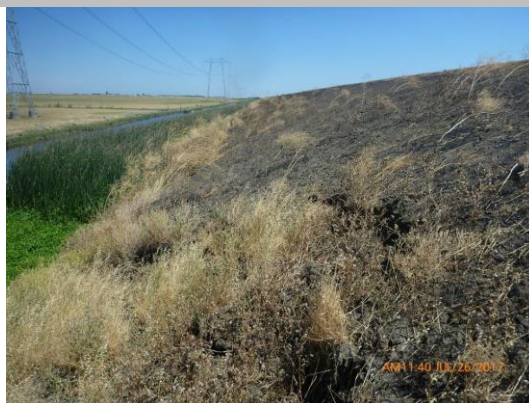
LM Start	4.30	Rating **	A/W	Issue No.	28
LM End	4.31	Issue Type +	Ma	Location *	LS
Category	Supplemental			GPS Latitude/Longitude	
				Start	End
Item	2017 Storm Damage			38.346200 °	38.346100 °
				-121.694000 °	-121.694000 °
DWR ID	DWR_RD2068_01_f_2017_28				
Comment Code					
Inspector Comment					
Levee Evaluation Comments					
Description:The damage consists of scour, cracking, and sloughing of the lower landside levee slope approximately 30 feet in length along the west (right) bank of Shag Slough (Yolo Bypass). See attached pages for photos.					
Site ID No:463					
Site Designation:LMA-290					
Repair Type: Stability					
Rating:Serious					
Field Date:7/26/2017					
Notes: 3' feet vertical cut at waterside levee toe from wavewash

LM Start	4.30	Rating **	A/W	Issue No.	28 (cont)
LM End	4.31	Issue Type +	Ma	Location *	LS
Category	Supplemental			GPS Latitude/Longitude	
				Start	End
Item	2017 Storm Damage			38.346200 °	38.346100 °
				-121.694000 °	-121.694000 °
DWR ID	DWR_RD2068_01_f_2017_28				
Comment Code					
Inspector Comment					
Levee Evaluation Comments					
Description:The damage consists of scour, cracking, and sloughing of the lower landside levee slope approximately 30 feet in length along the west (right) bank of Shag Slough (Yolo Bypass). See attached pages for photos.					
Site ID No:463					
Site Designation:LMA-290					
Repair Type: Stability					
Rating:Serious					
Field Date:7/26/2017					
Notes: 3' feet vertical cut at waterside levee toe from wavewash

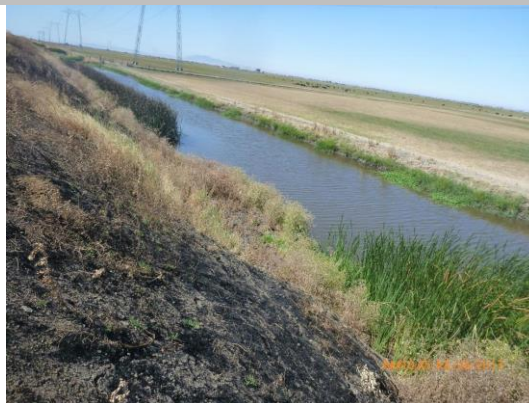
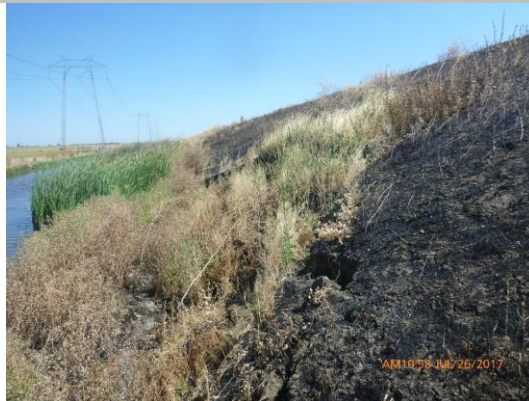
LM Start	4.39	Rating **	A/W	Issue No.	29
LM End	4.40	Issue Type +	Ma	Location *	LS
Category	Supplemental			GPS Latitude/Longitude	
				Start	End
Item	2017 Storm Damage			38.344900 °	38.344800 °
				-121.694000 °	-121.694000 °
DWR ID	DWR_RD2068_01_f_2017_29				
Comment Code					
Inspector Comment					
Levee Evaluation Comments					
Description:The damage consists of scour, cracking, and sloughing of the lower landside levee slope approximately 30 feet in length along the west (right) bank of Shag Slough (Yolo Bypass). See attached pages for photos.					
Site ID No:464					
Site Designation:LMA-291					
Repair Type: Stability					
Rating:Serious					
Field Date:7/26/2017					
Notes: 2' feet vertical cut at waterside levee toe from wavewash

LM Start	4.39	Rating **	A/W	Issue No.	29 (cont)	
LM End	4.40	Issue Type +	Ma	Location *	LS	
Category	Supplemental			GPS Latitude/Longitude		
				Start	End	
Item	2017 Storm Damage			38.344900 °	38.344800 °	
				-121.694000 °	-121.694000 °	
DWR ID	DWR_RD2068_01_f_2017_29					
Comment Code						
Inspector Comment						
Levee Evaluation Comments						
Description:The damage consists of scour, cracking, and sloughing of the lower landside levee slope approximately 30 feet in length along the west (right) bank of Shag Slough (Yolo Bypass). See attached pages for photos.						
Site ID No:464						
Site Designation:LMA-291						
Repair Type: Stability						
Rating:Serious						
Field Date:7/26/2017						
Notes: 2' feet vertical cut at waterside levee toe from wavewash

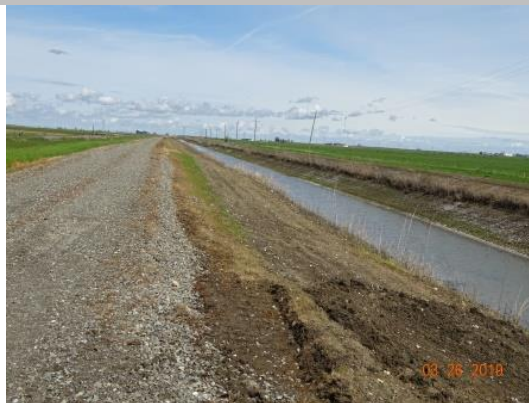
Photo 1 of 1 : SP_2019_RD2068_194_12_20190326_00010.jpg

LM Start	0.02	Rating **	A	Issue No.	12
LM End	2.23	Issue Type +	Ma	Location *	LS
Category	Earthen Levee			GPS Latitude/Longitude	
				Start	End
Item	Vegetation			38.358405 °	38.387065 °
				-121.740403 °	-121.726167 °
DWR ID	DWR_RD2068_02_s_2019_12				
Comment Code					
V1 : Control annual grass and weeds on the levee slopes and easements.					
Inspector Comment					
Annual vegetation is well maintained on the landside slope.

View looking upstream at the well maintained vegetation on the landside slope (Spring 2019).

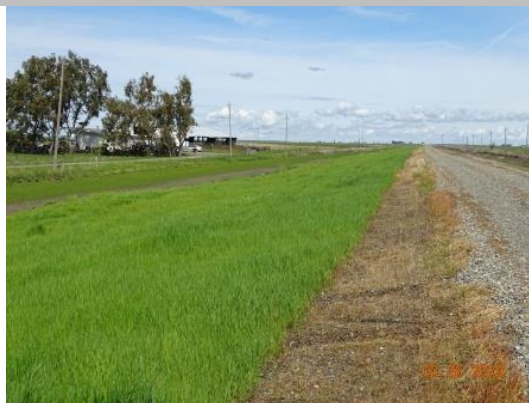
Photo 1 of 1 : SP_2019_RD2068_194_13_20190326_00009.jpg

LM Start	0.02	Rating **	A	Issue No.	13
LM End	2.23	Issue Type +	Ma	Location *	WS
Category	Earthen Levee			GPS Latitude/Longitude	
				Start	End
Item	Vegetation			38.358405 °	38.387065 °
				-121.740403 °	-121.726167 °
DWR ID	DWR_RD2068_02_s_2019_13				
Comment Code					
V1 : Control annual grass and weeds on the levee slopes and easements.					
Inspector Comment					
Annual vegetation is well maintained on the waterside slope.

View looking upstream at well maintained vegetation on the waterside slope (Spring 2019).

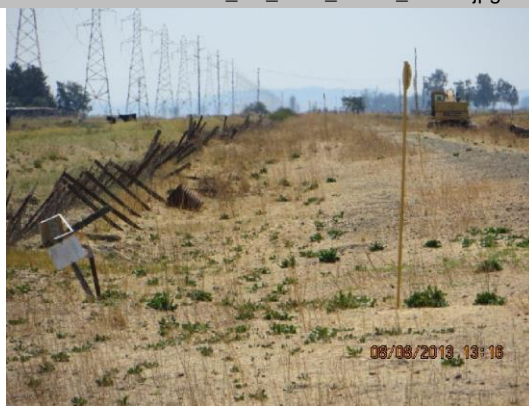
Photo 1 of 2 : UCIP_SP_2019_17531_29641.jpg

Comment Code					
Inspector Comment					
FS_ID:17531 DS_ID:19355 EP_NO: 8151 Repair Type: Non-Urgent Crossing Status: Indicator Found UCIP Comments: 12/22/2016 Met with Mike Hadesty, LMA Superintendent, and Brian Bush, LMA General Manager, to go over the list of pipes in RD2068. Per LMA records, line is an active line. New owner is Calpine. Need to coordinate with Calpine to update permit and obtain records to confirm line integrity. (O. Magana - DWR UCIP) 08/08/2013 Appears abandoned. Need to verify with pipeline owner. (W. Wylie - DWR UCIP) FIELD_STRUCT_DESC: 8-inch coated steel gas line through the levee, 3 feet below the crown. Gas line markers visible on the east toe of the levee at the intersection of the levee and Delhi Road. (Permit No. 8151, 1972 - Dow Chemical). [Additional Reference(s): DWR Levee Log, 1992]. FS Date: 8/8/2013

Gasline markers next to old rail road grade, looking south.

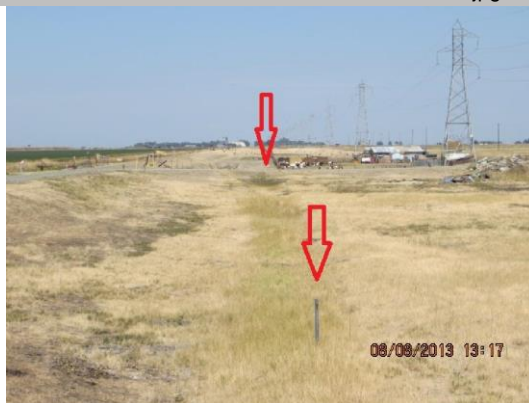
Photo 2 of 2 : UCIP_SP_2019_17531_29640.jpg

Gasline markers on east side of levee toe looking North.

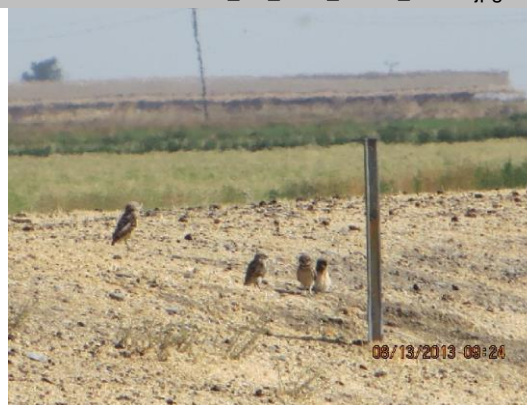
Photo 1 of 3 : UCIP_SP_2019_17532_29644.jpg

LM Start	1.07	Rating **	M	Issue No.	22
LM End	1.07	Issue Type +	En	Location *	
Category	Supplemental			GPS Latitude/Longitude	
				Start	End
Item	DWR UCIP Field Study			38.373330 °	38.373330 °
				-121.738530 °	-121.738530 °
DWR ID	19354				
Comment Code					
Inspector Comment					
FS_ID:17532 DS_ID:19354 EP_NO: 13028 Repair Type: Non-Urgent Crossing Status: Indicator Found UCIP Comments: 08/13/2013 Need improved signage on LS and WS shoulders. (W. Wylie - DWR UCIP) FIELD_STRUCT_DESC: 10-inch coated steel pipe through the levee, 2 feet below the crown. 4-inch gas line sleeved through the 10-inch pipe. Sign missing from marker post on east slope. 2-inch vent pipe with identification sign off the west bank of the levee and off the toe of the east side of the levee at the fence. (Permit No. 13028, 1980 - Shell Oil Company). FS Date: 8/13/2013

Sign post without markings on WS slope.
